Evaluation of Thermoplastic Marking Materials

May 2008

DOT/FAA/AR-TN08/22

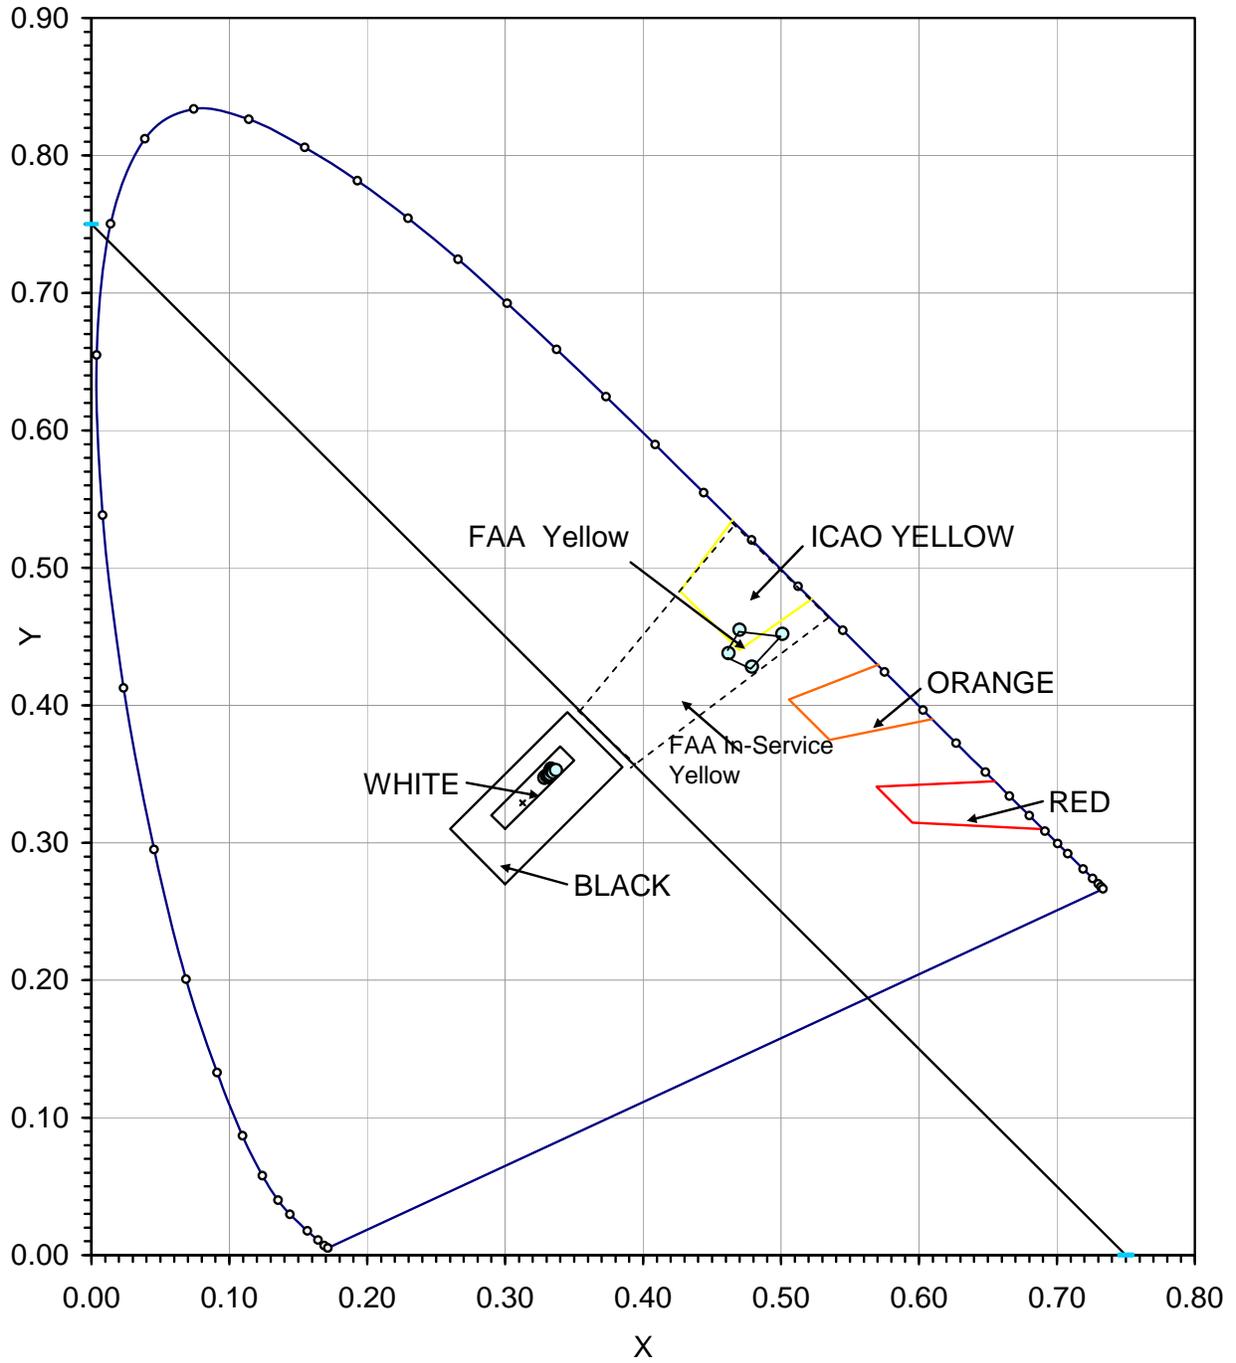
Figure A-22. Chromaticity Readings of CCWS-1, 3-Foot Stripe (White) at FAA William J. Hughes Technical Center

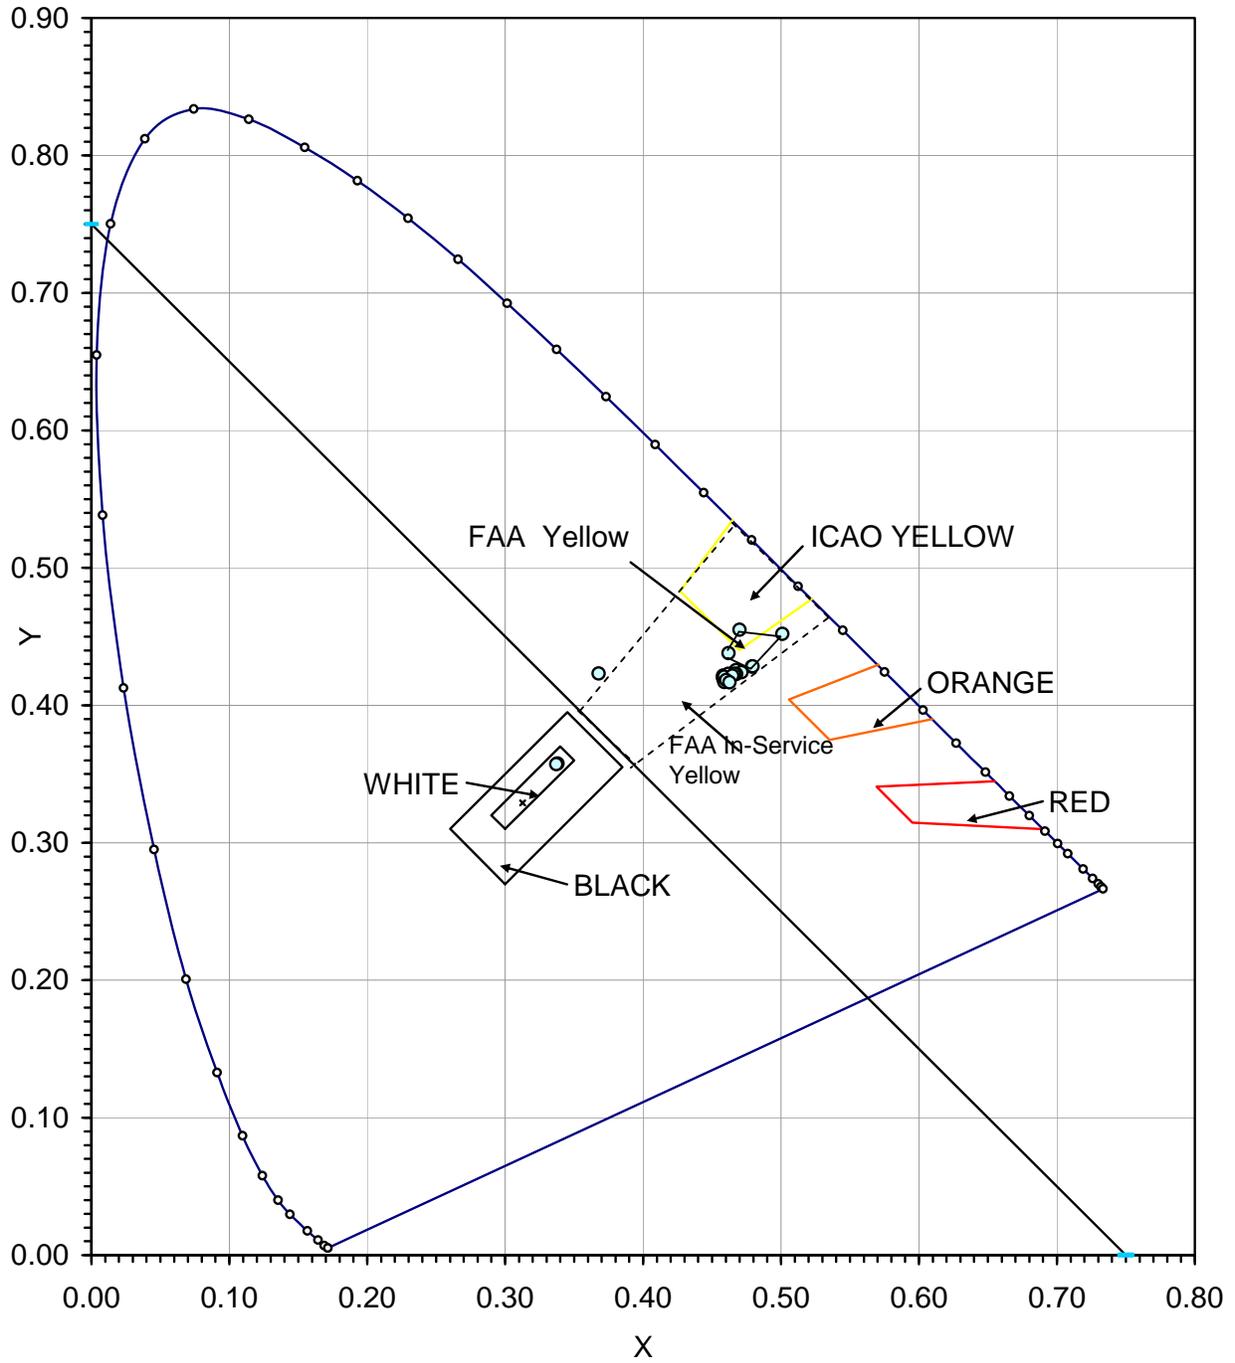
Figure A-23. Chromaticity Readings of CCYS-1, 3-Foot Stripe (Yellow) at FAA William J. Hughes Technical Center

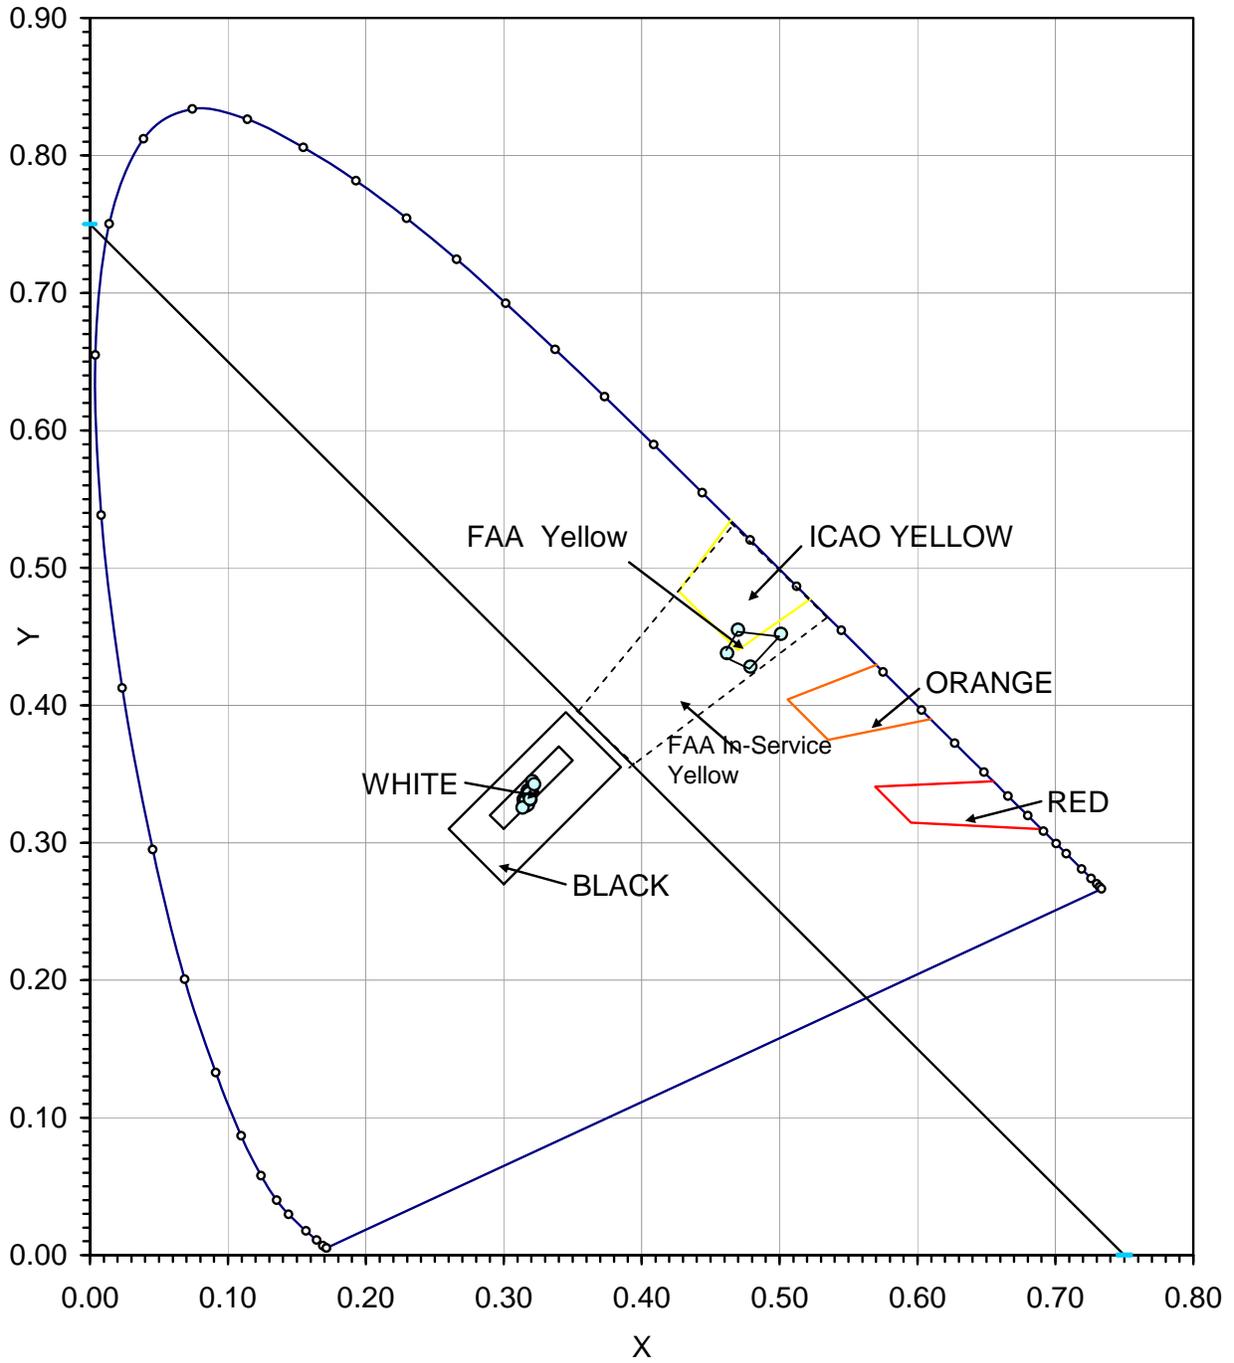
Figure A-24. Chromaticity Readings of CCBS-1, 3-Foot Stripe (Black) at FAA William J. Hughes Technical Center

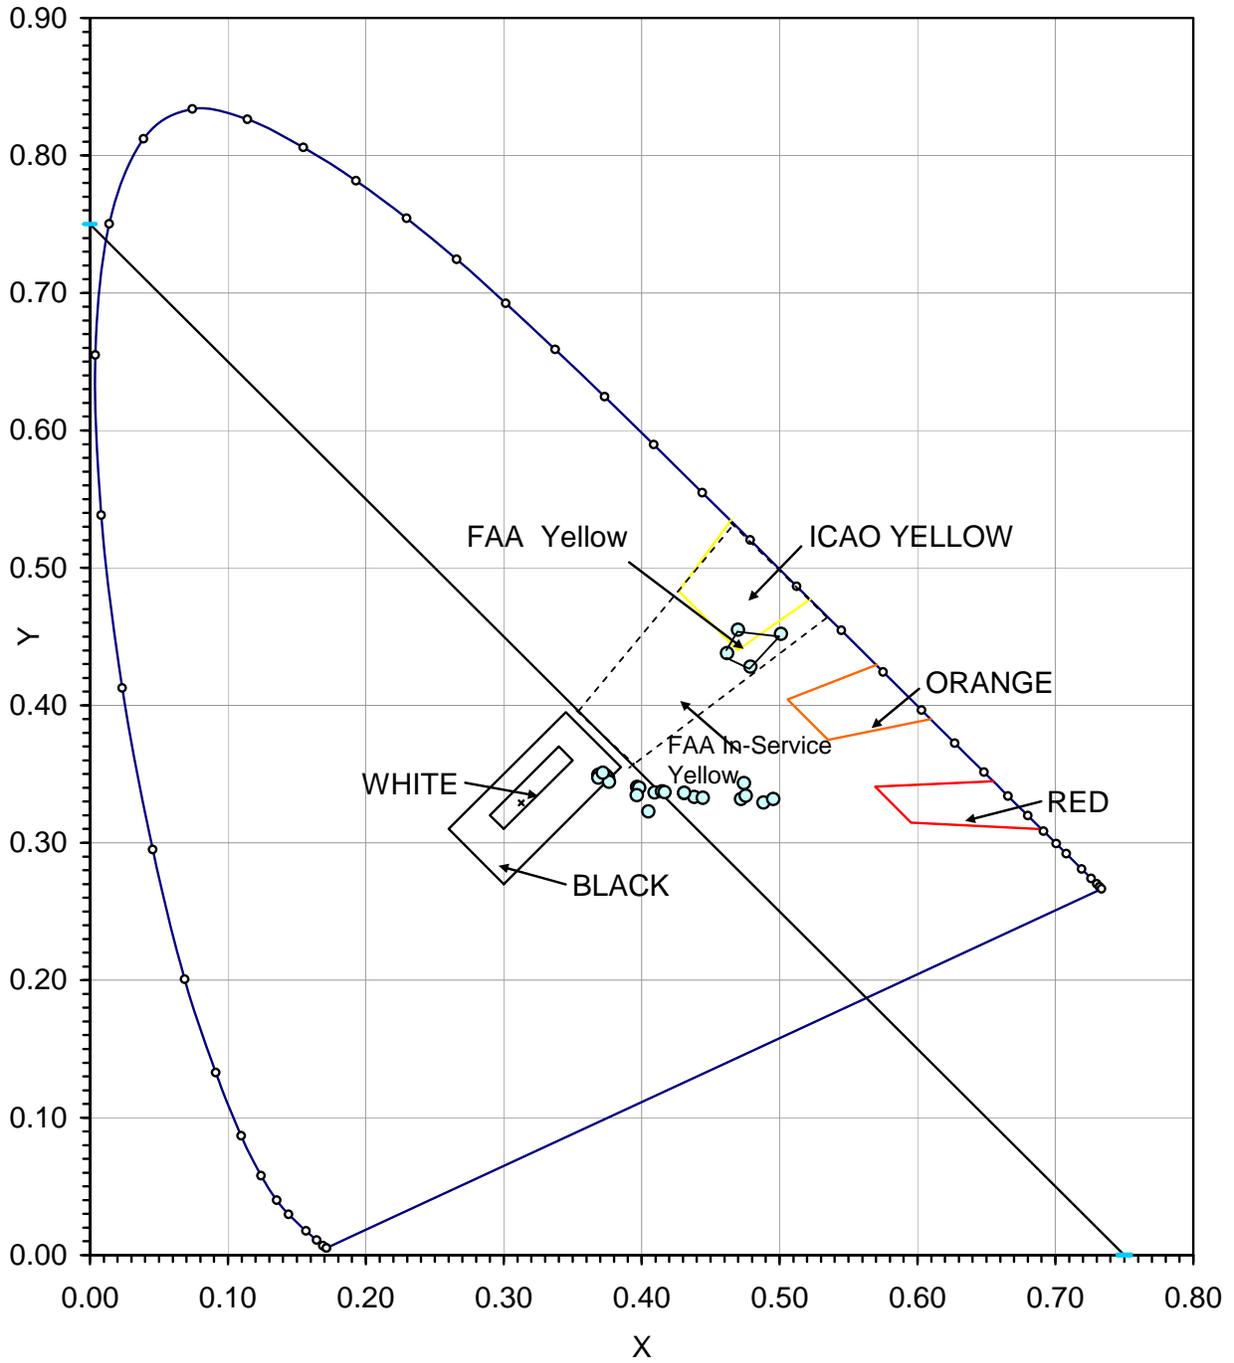
Figure A-25. Chromaticity Readings of HMRS-1, 3-Foot Stripe (Red) at FAA William J. Hughes Technical Center

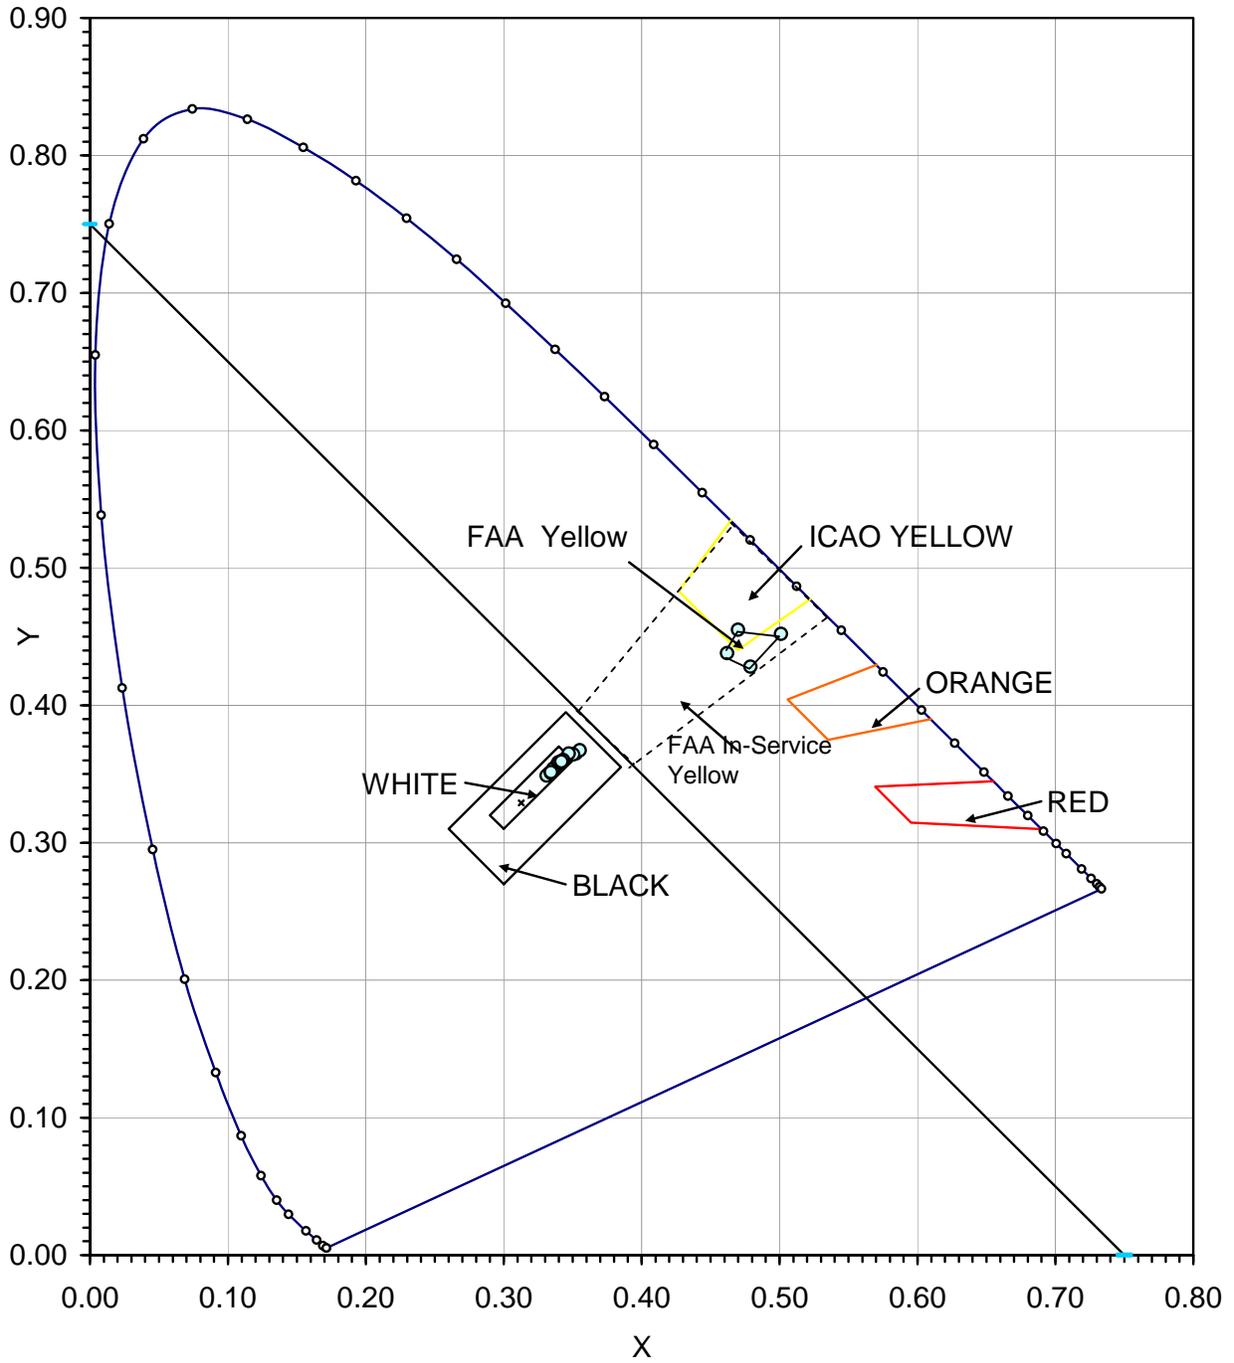
Figure A-26. Chromaticity Readings of HMWS-1, 3-Foot Stripe (White) at FAA William J. Hughes Technical Center

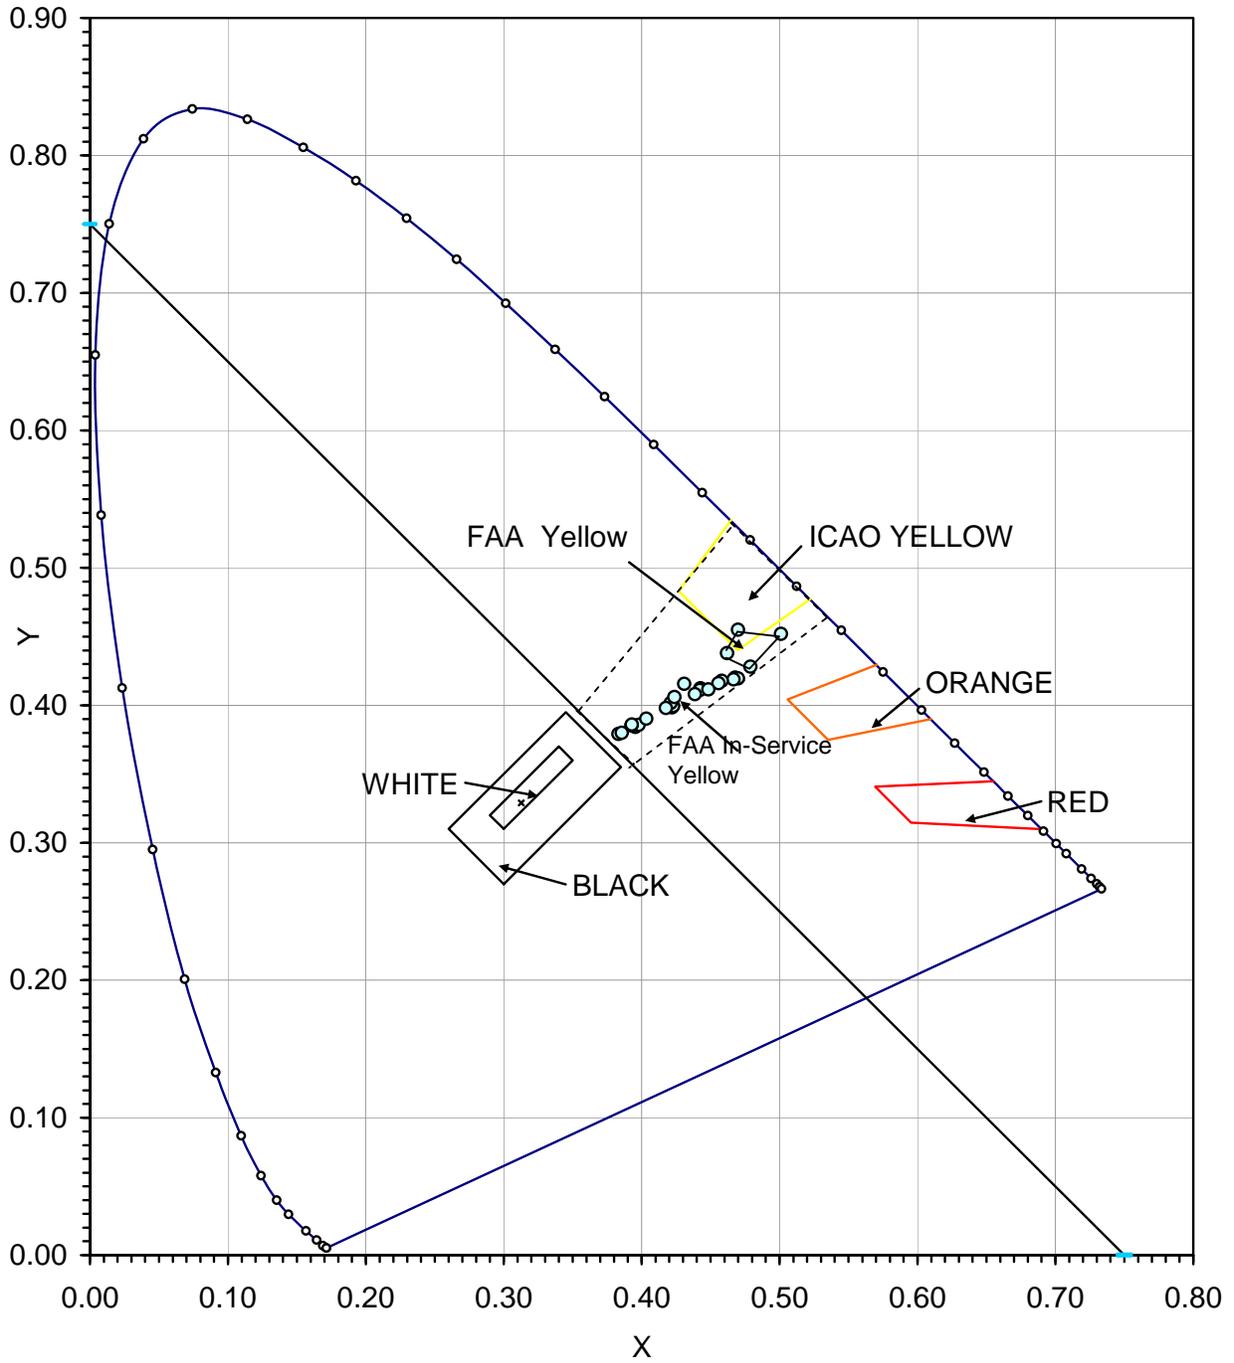
Figure A-27. Chromaticity Readings of HMYS-1, 3-Foot Stripe (Yellow) at FAA William J. Hughes Technical Center

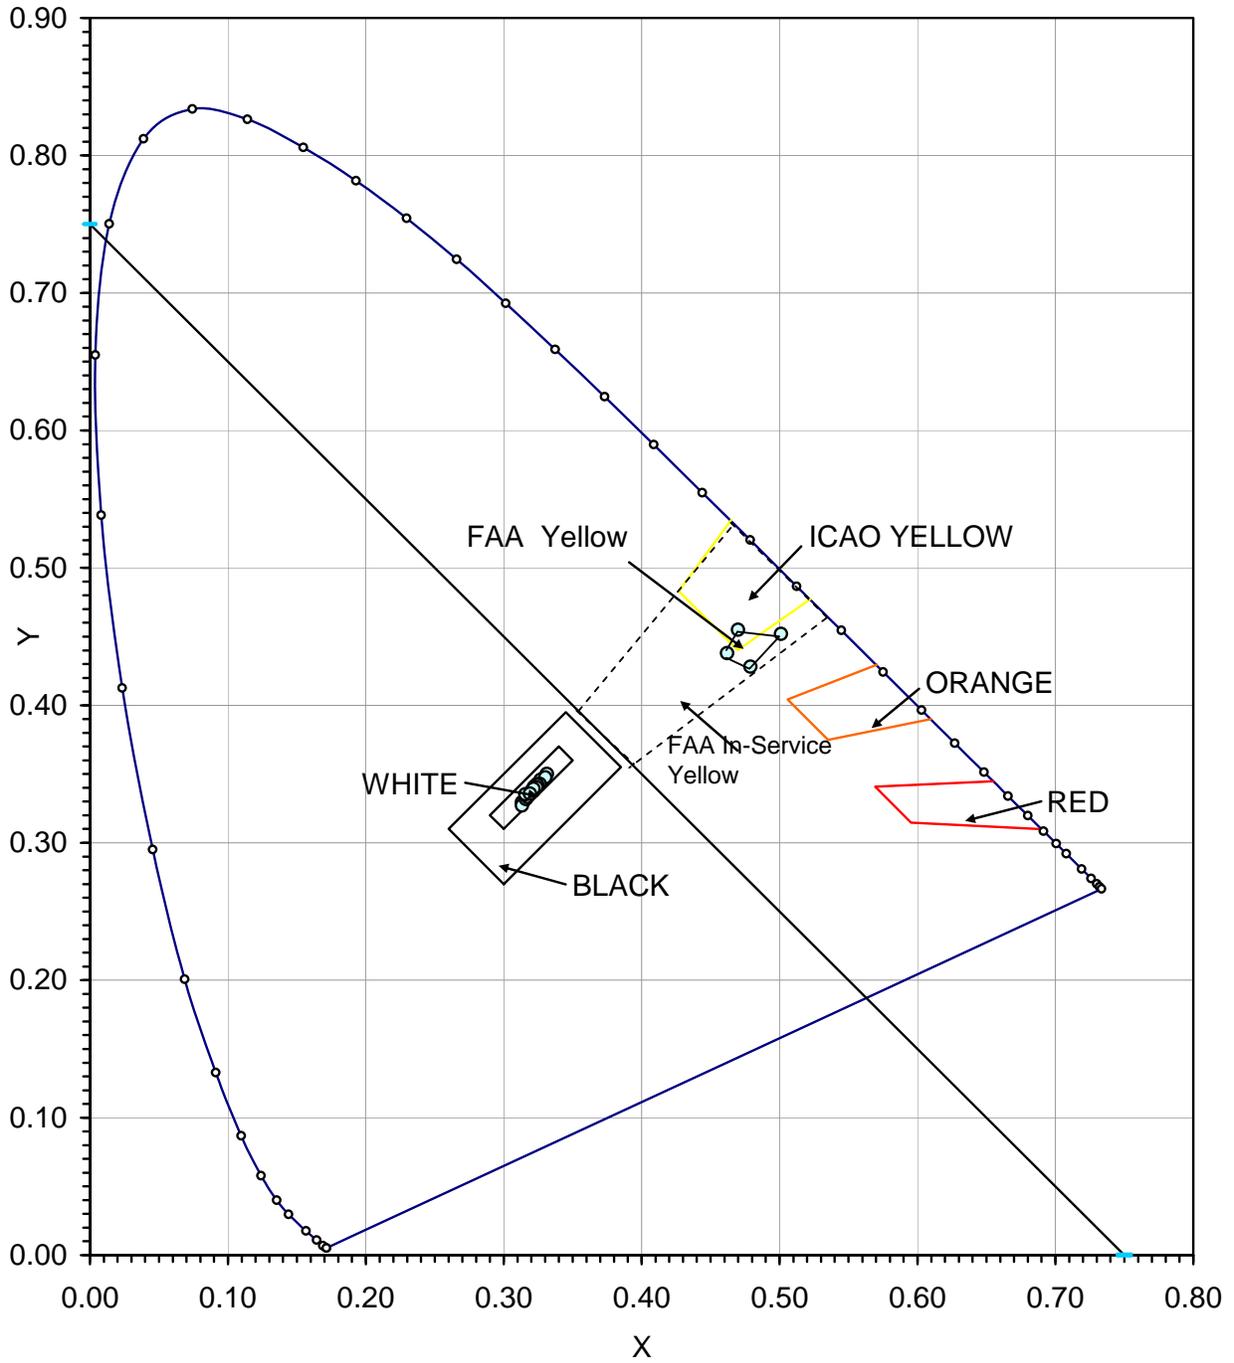
Figure A-28. Chromaticity Readings of HMBS-1, 3-Foot Stripe (Black) at FAA William J. Hughes Technical Center

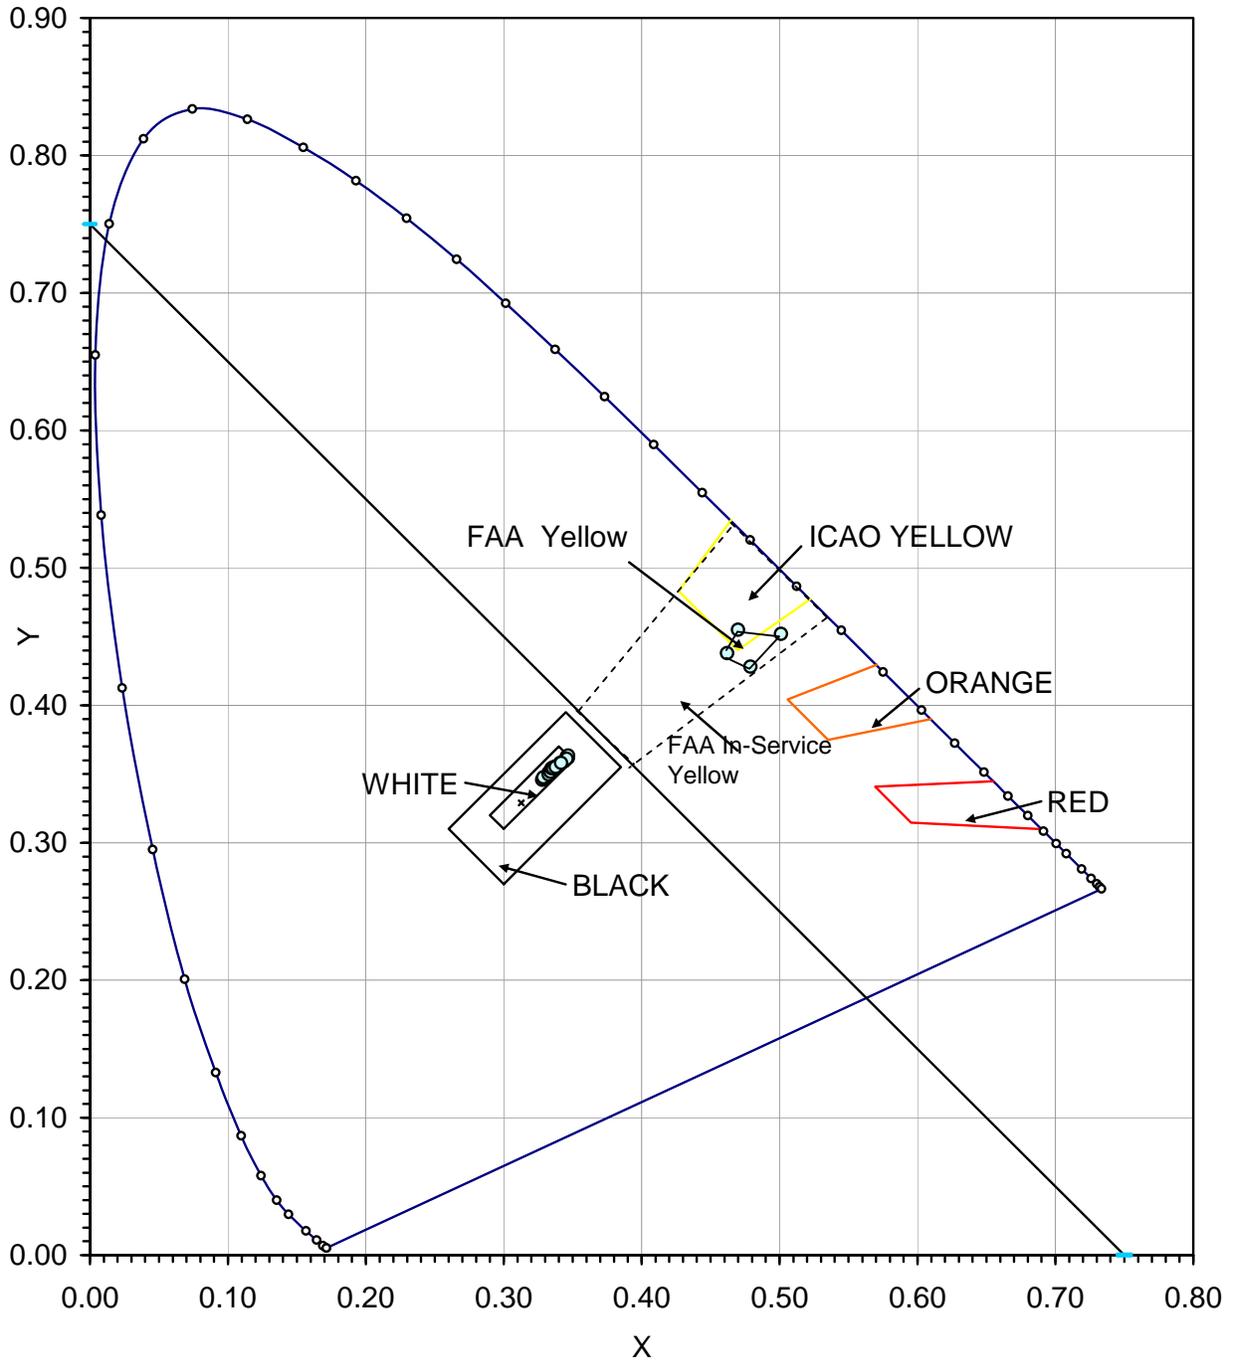
Figure A-29. Chromaticity Readings of HMWSL-1, 150-Foot Stripe (White) at FAA William J. Hughes Technical Center

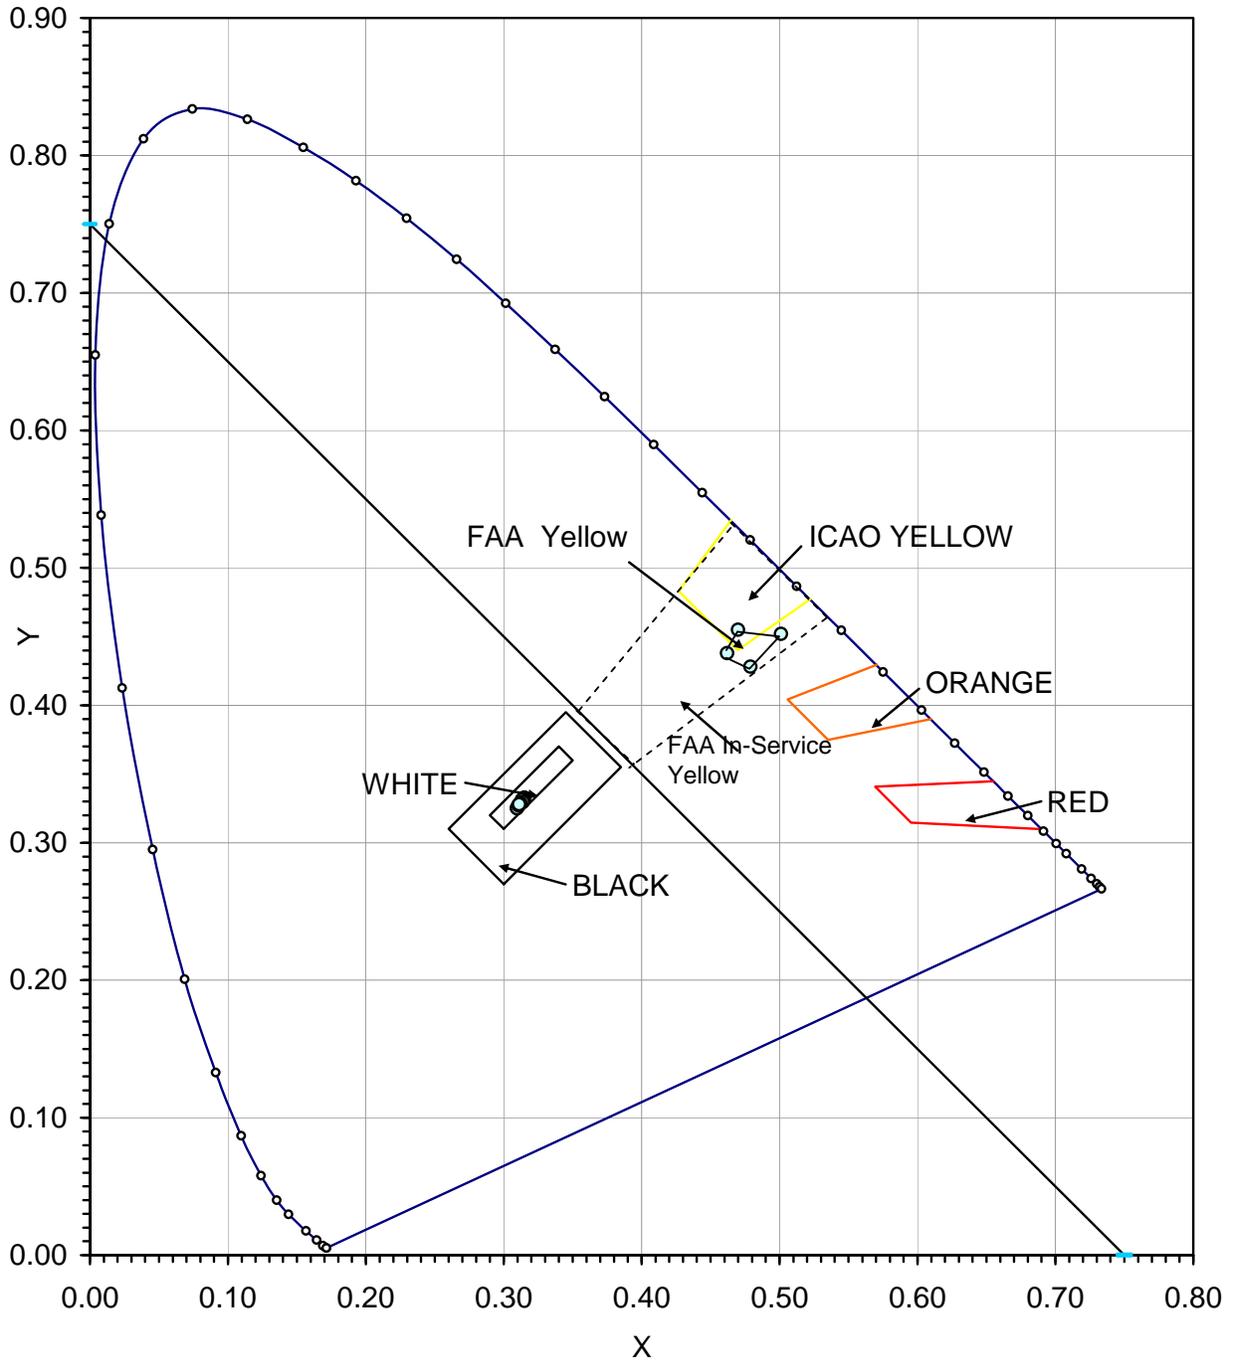
Figure A-30. Chromaticity Readings of CCMNB-2, Movement/Nonmovement Line (Black) at FAA William J. Hughes Technical Center

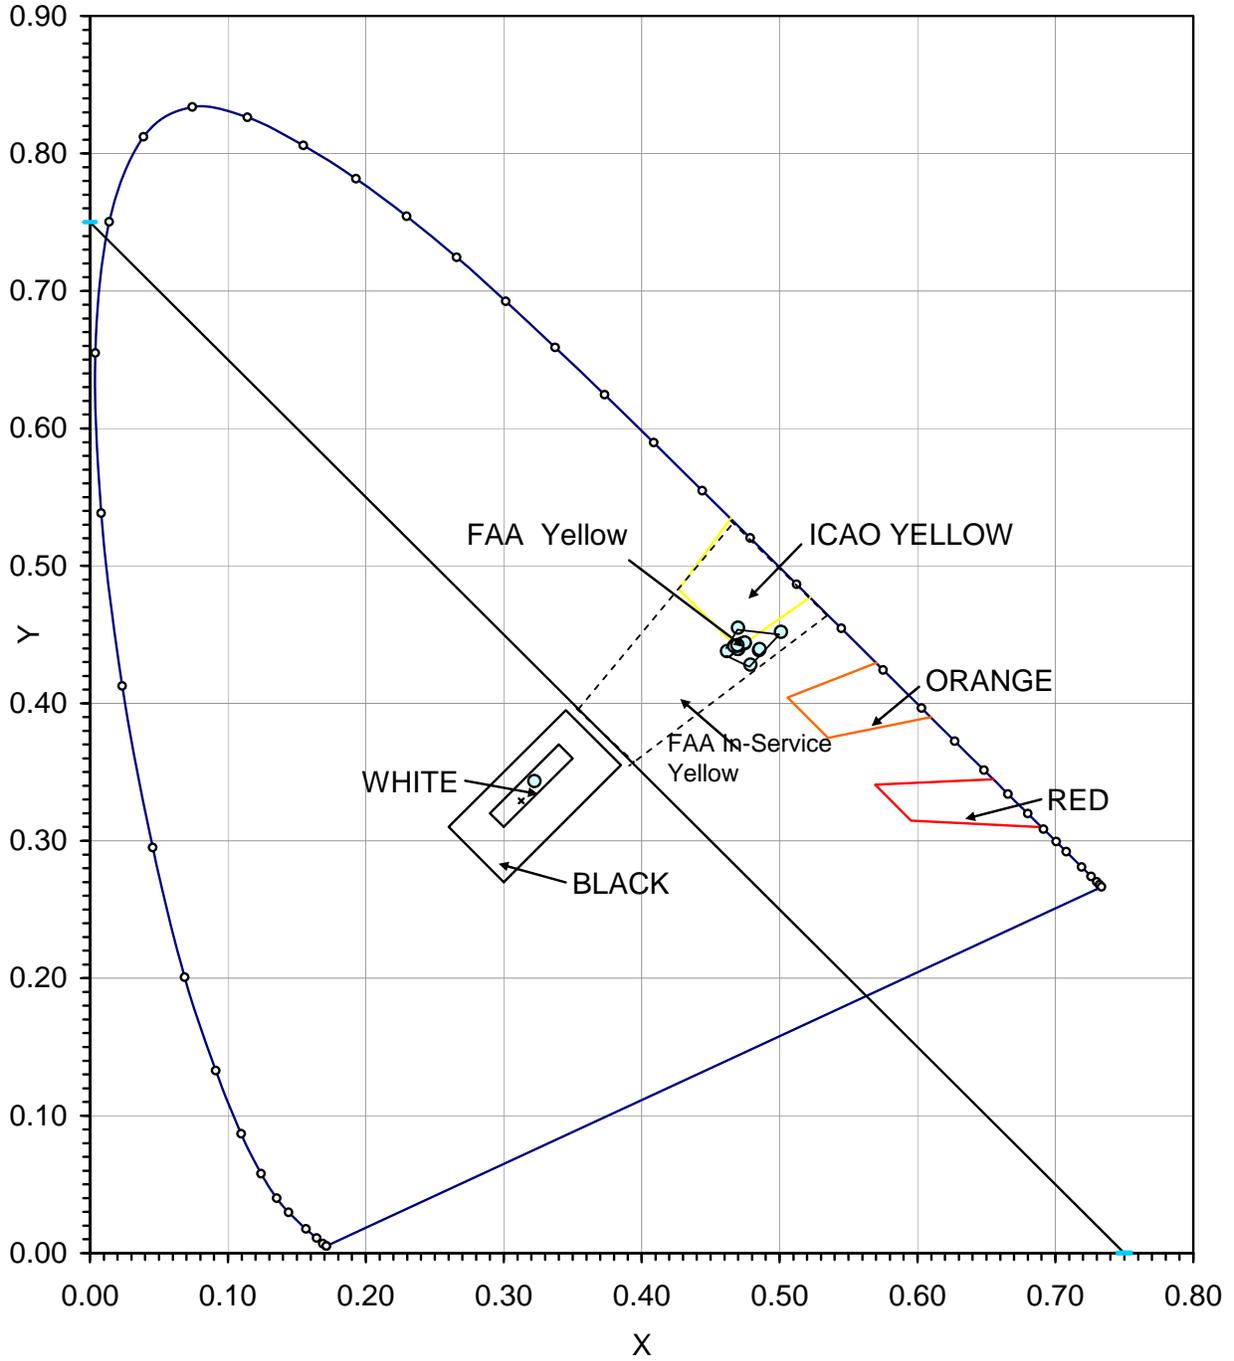
Figure A-31. Chromaticity Readings of CCMNY-2, Movement/Nonmovement Line (Yellow) at FAA William J. Hughes Technical Center

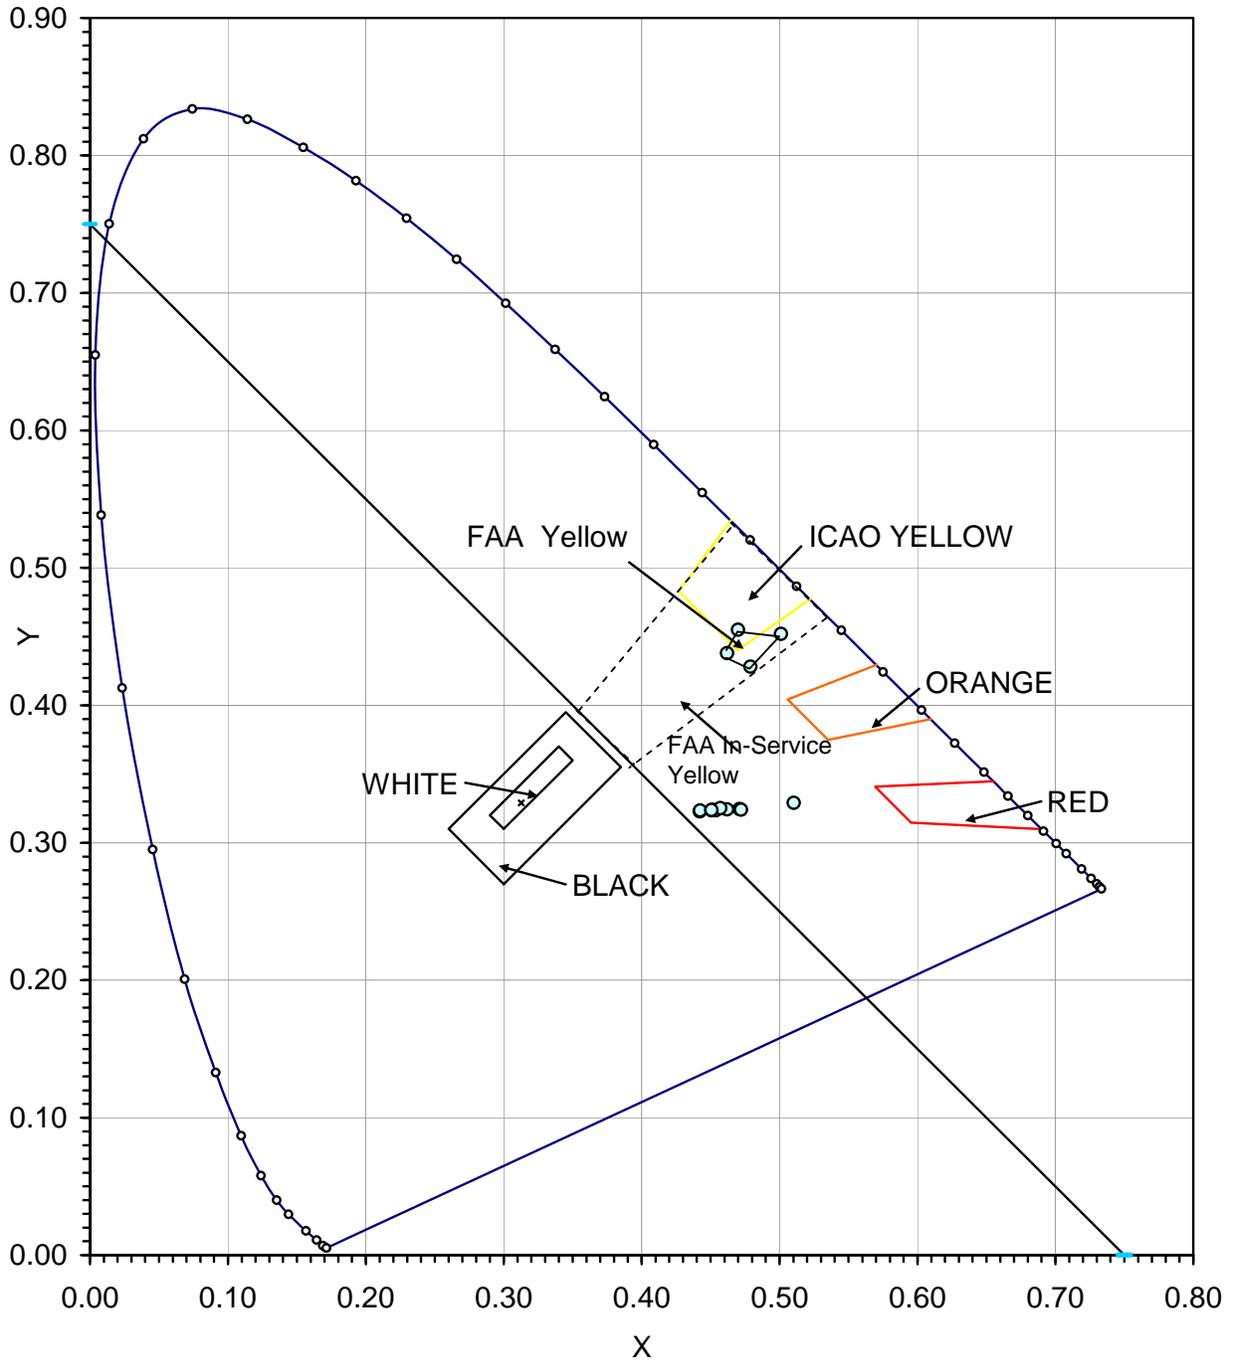
Figure A-32. Chromaticity Readings of CCAPD8R-2, Aircraft Parking Designator #8 (Red) at FAA William J. Hughes Technical Center

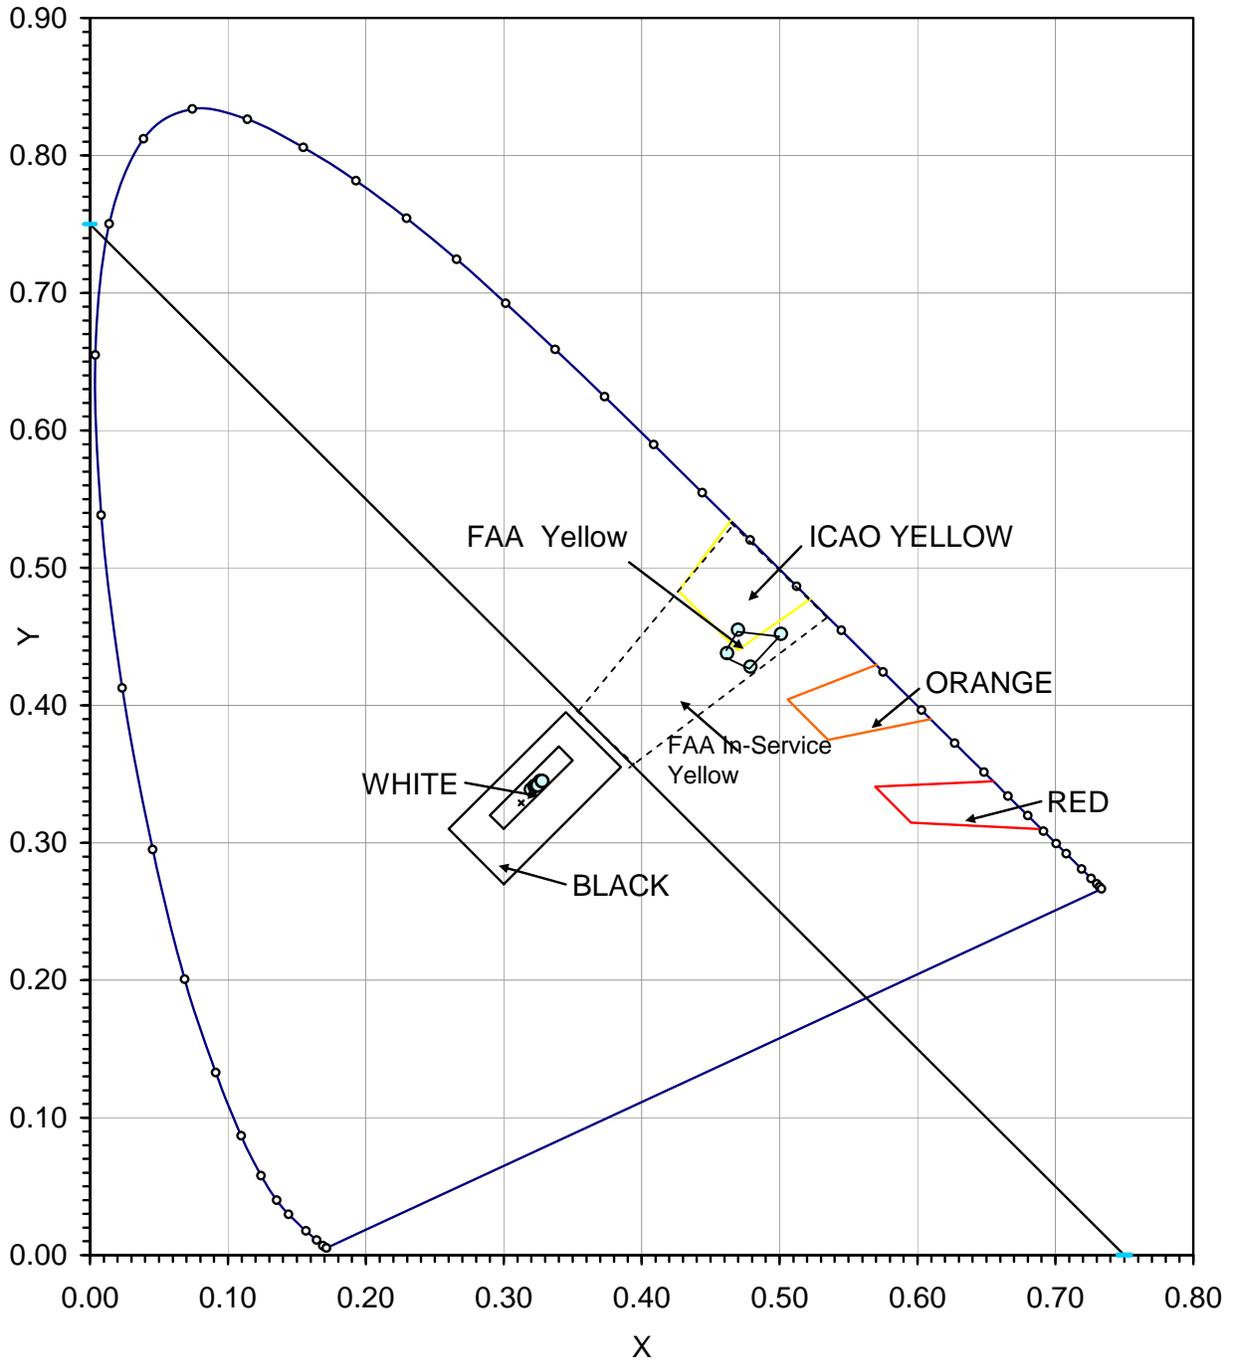
Figure A-33. Chromaticity Readings of CCAPD8W-2, Aircraft Parking Designator #8 (White) at FAA William J. Hughes Technical Center

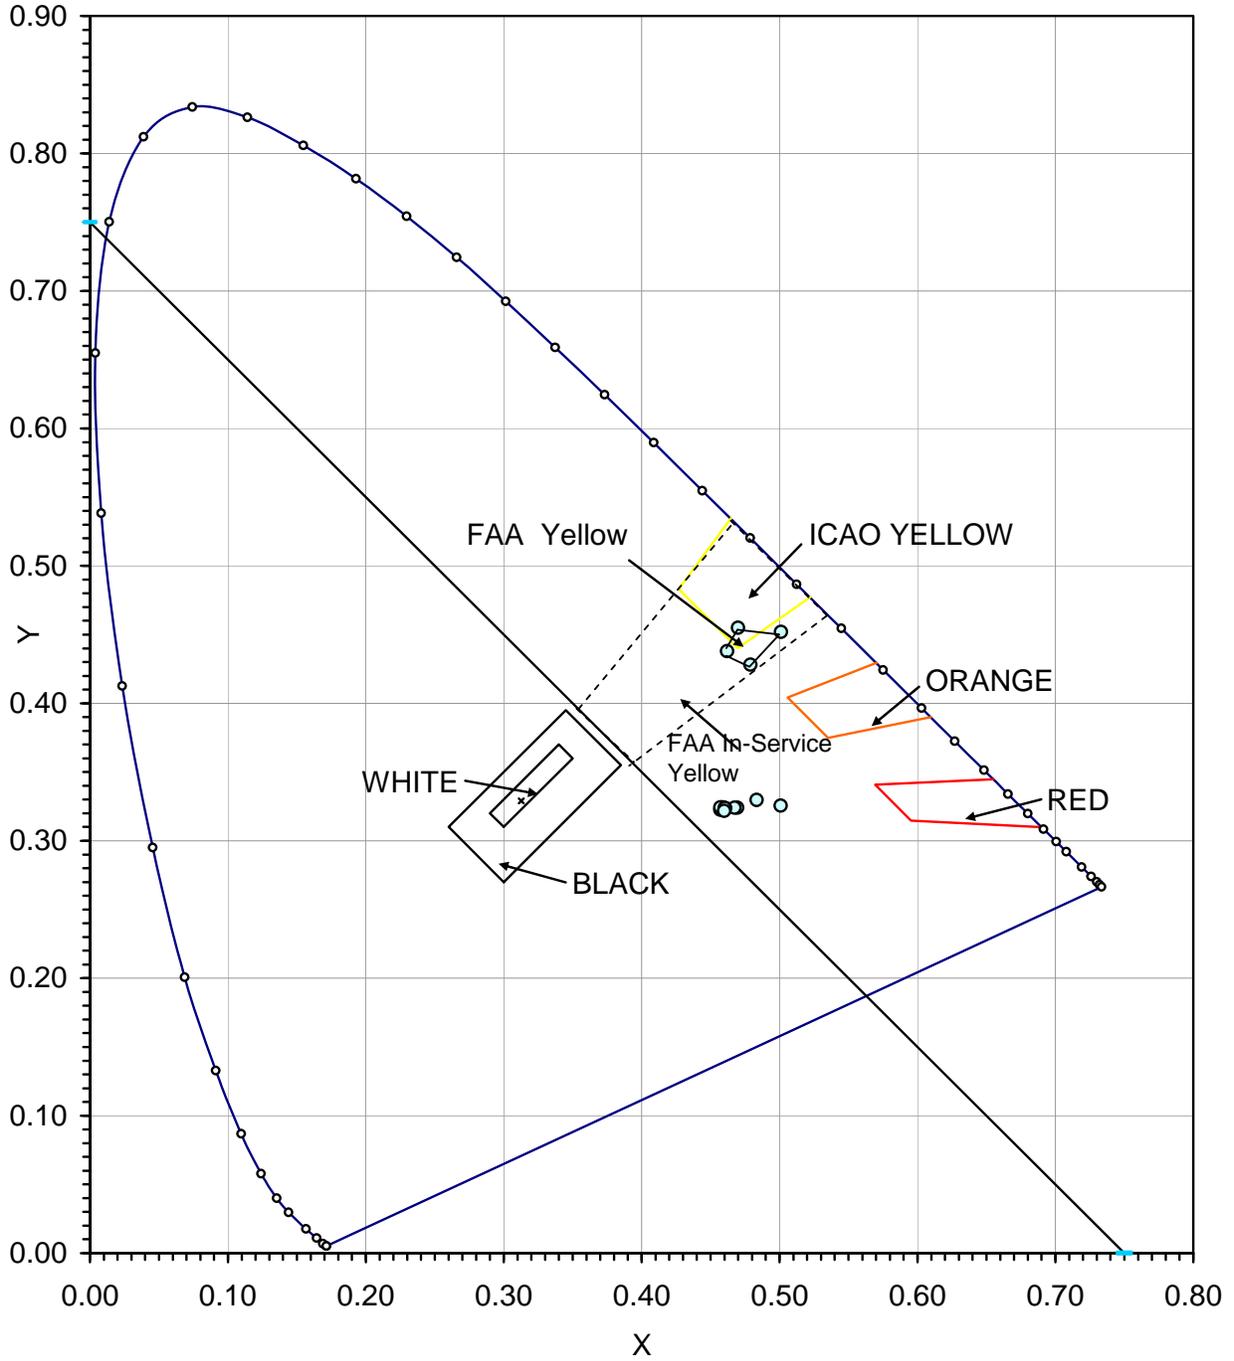
Figure A-34. Chromaticity Readings of CCRS-2, 3-Foot Stripe (Red) at FAA William J. Hughes Technical Center
